## **Dam Safety in Communities**

Tony Fletcher PE  
State Dam Inspector

*Maine Dam Safety Program, Office of Dam Safety, Maine Emergency Management Agency (MEMA)  
Maine Department of Defense, Veterans and Emergency Management (MDVEM)  
45 Commerce Drive, Augusta, ME 04333. Telephone 207-624-4400*

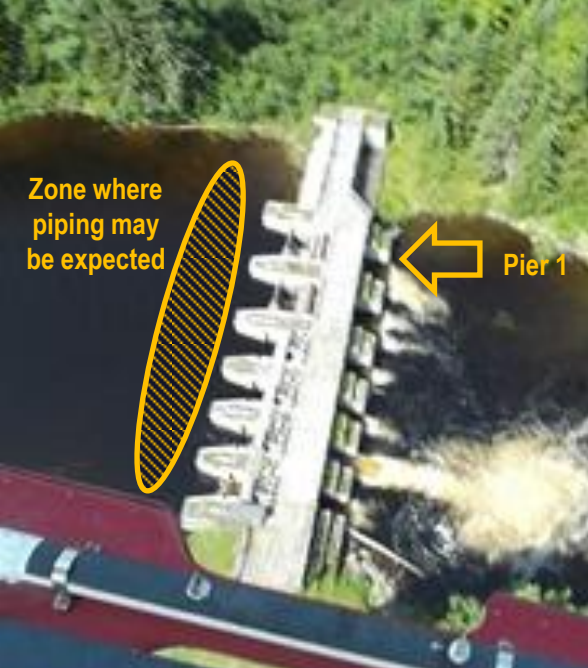
1. Telos dam from 400' right

## #41 Telos Dam

Defects:  
Wood Rot  
Pier Movement

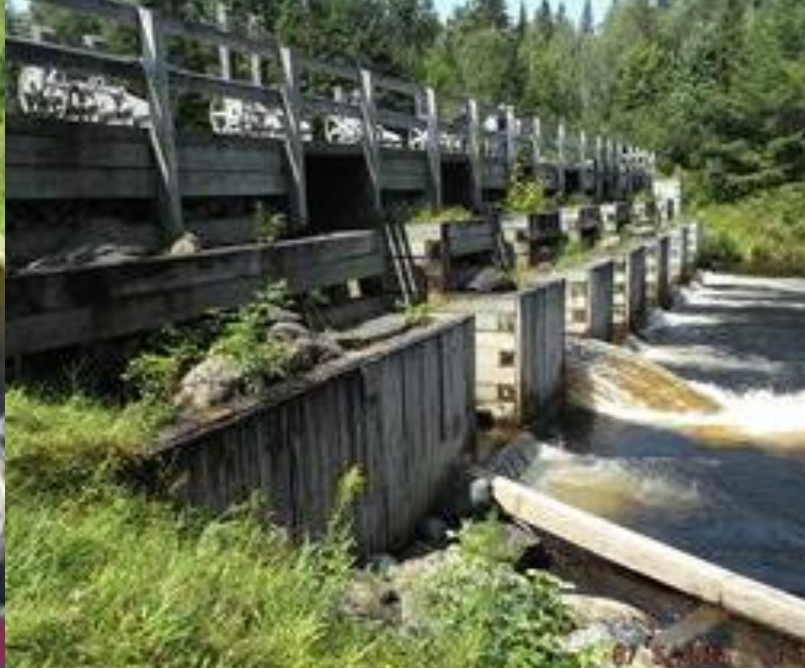
2. Telos dam from downstream right bank – one gate open

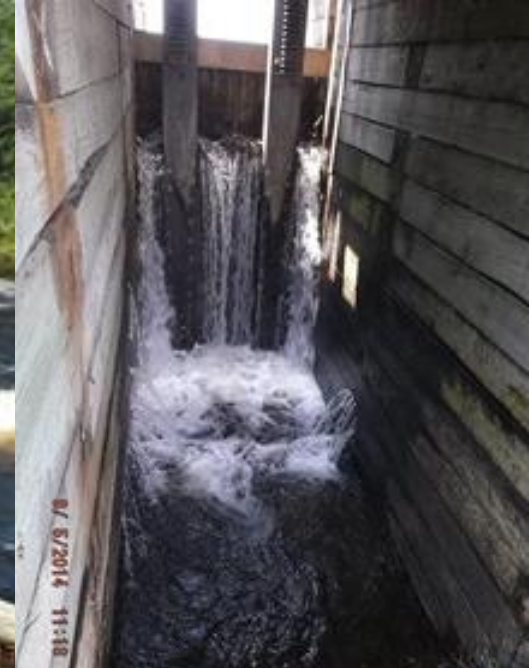
3. Telos Dam gate #6

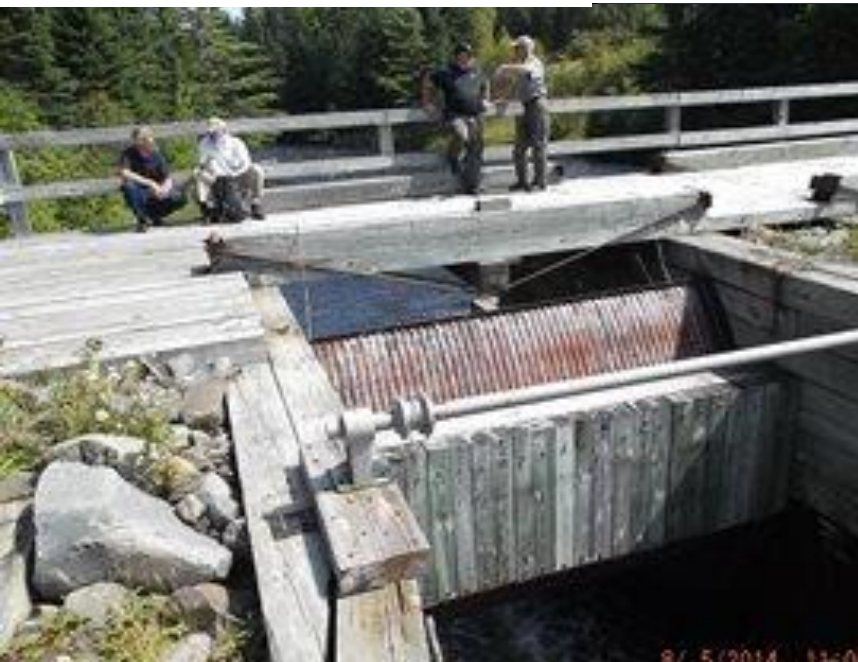
4. De-commissioned Radial Gate from pier #2

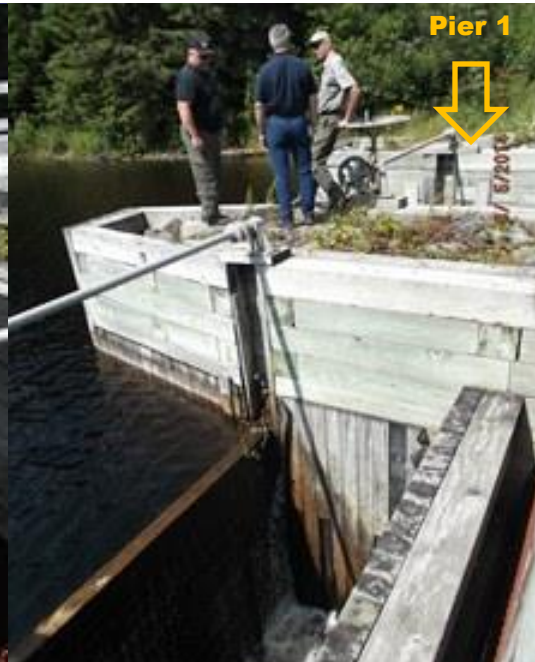
5. Telos dam pier #2 upstream

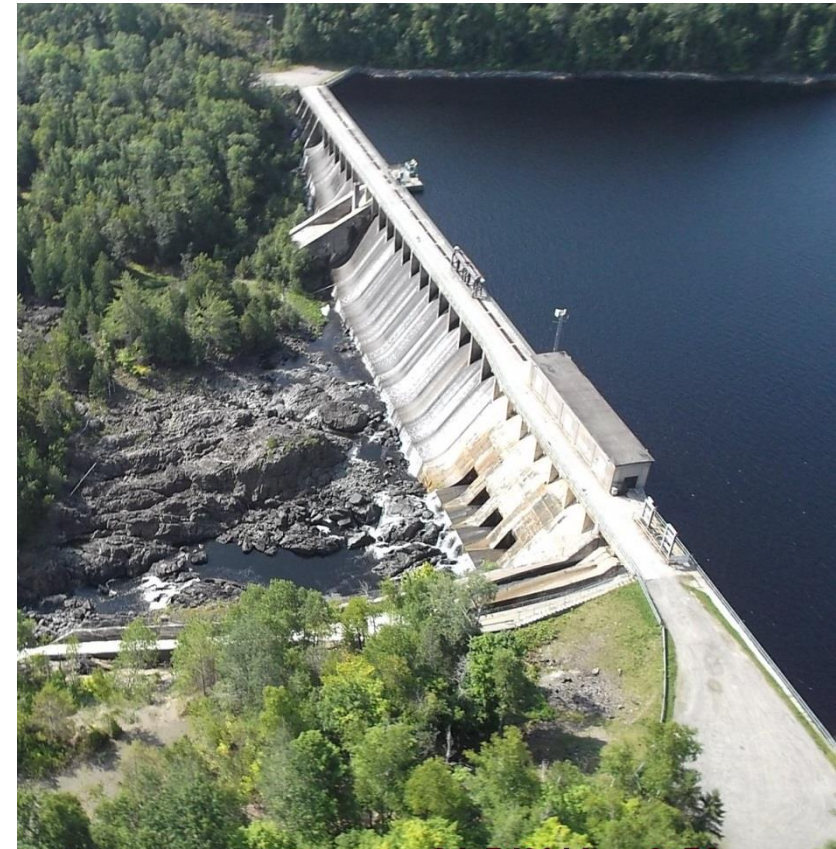
# Gravity Forces Acting on a Dam

**Example - Ripogenus Dam**  
**Concrete Mass Gravity 83' High, 780' Long**

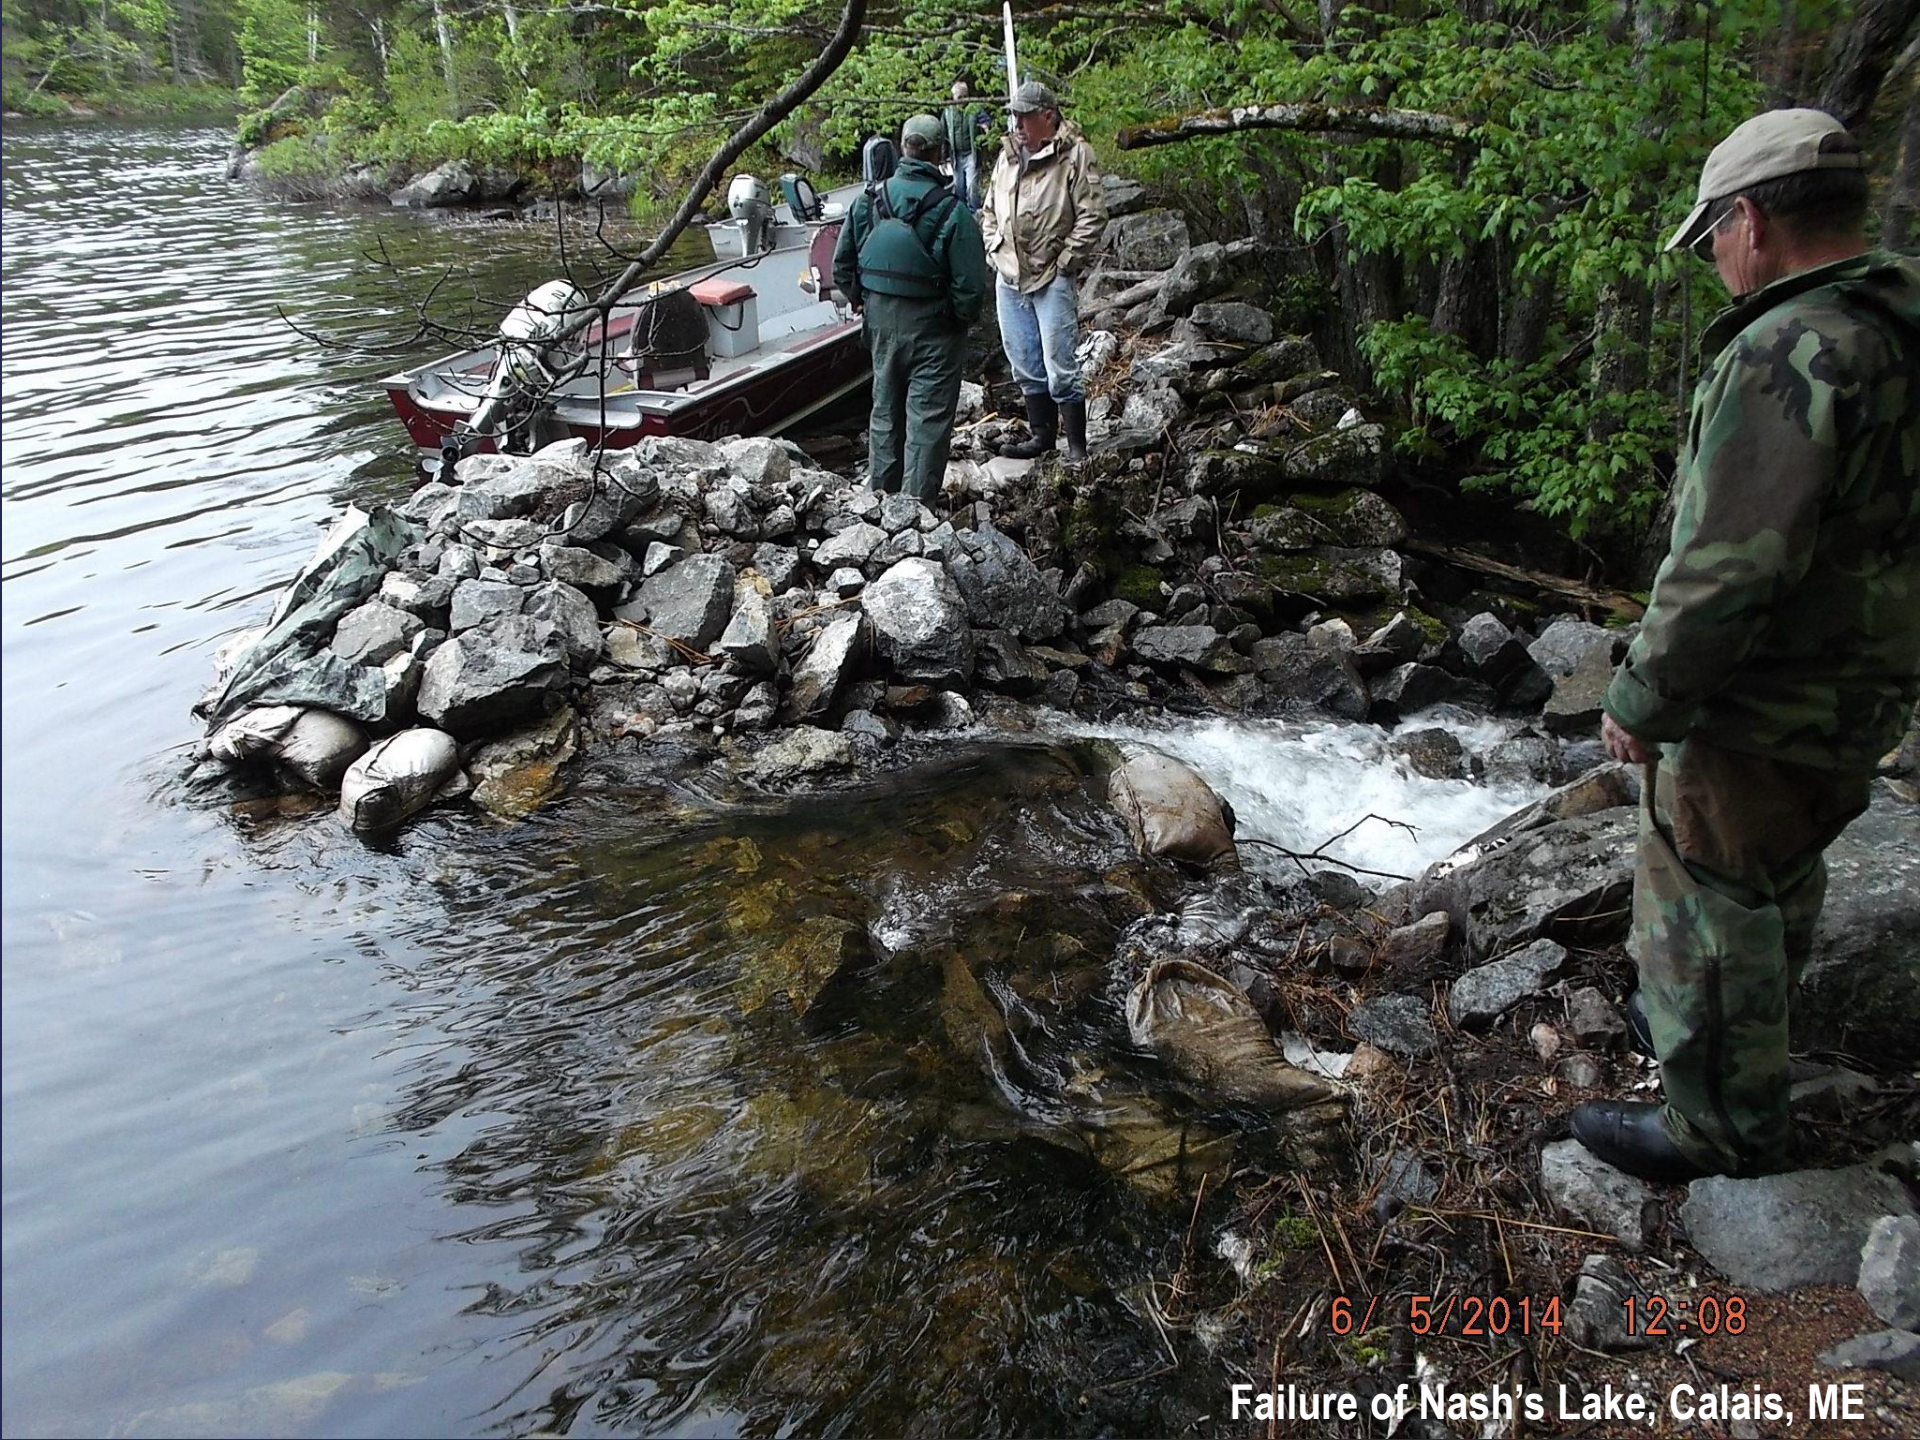
Failure of Nash's Lake, Calais, ME

- ❑ Repair of sloughs and slides found on a dam, to prevent water infiltrating into the dam and improve dam stability.

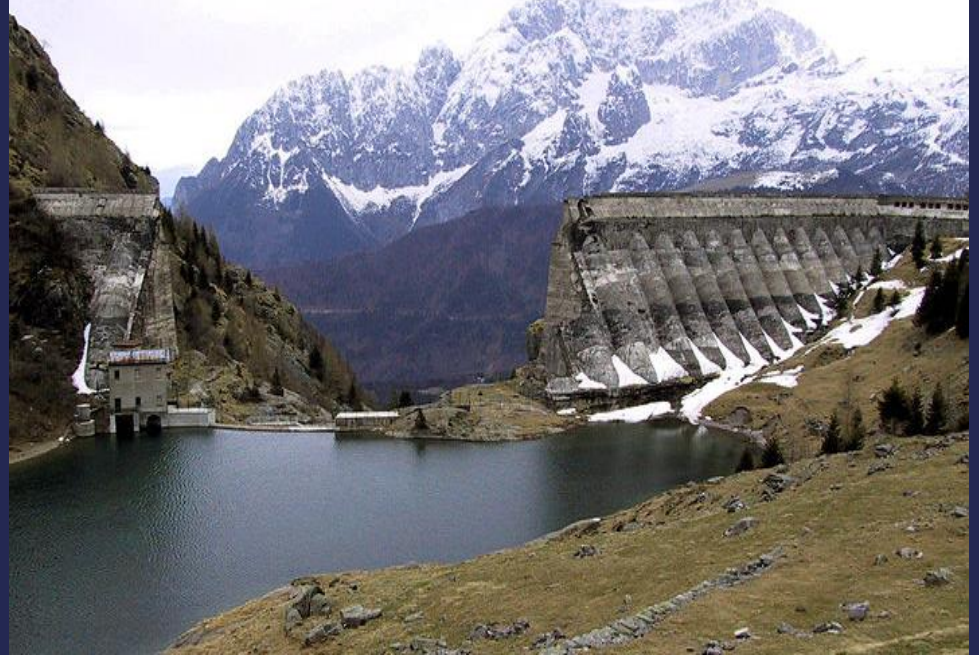
# Gleno Dam, Italy

Cause – Buttress collapse attributed to; Design, material & construction deficiencies.

Remarks - To save concrete, the design was changed from MG to arch buttress. Weak concrete containing scrap WW1 anti-grenade netting as reinforcement. Workers that reported poor workmanship were fired.

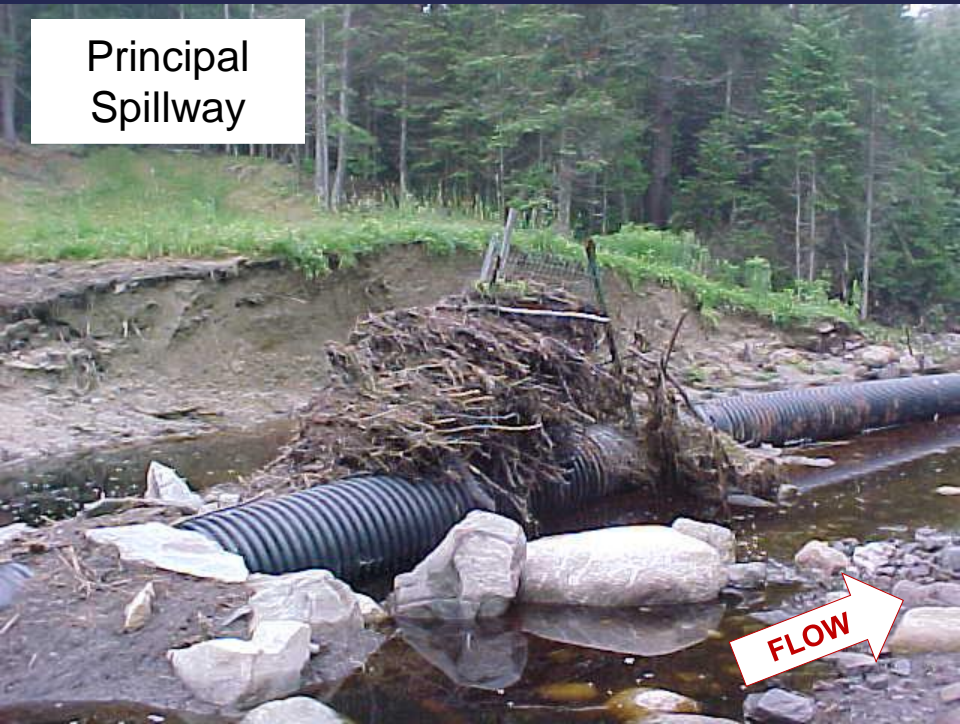
Dam principal  
spillway, PVC  
Riser fitted with  
stop-log – note  
debris

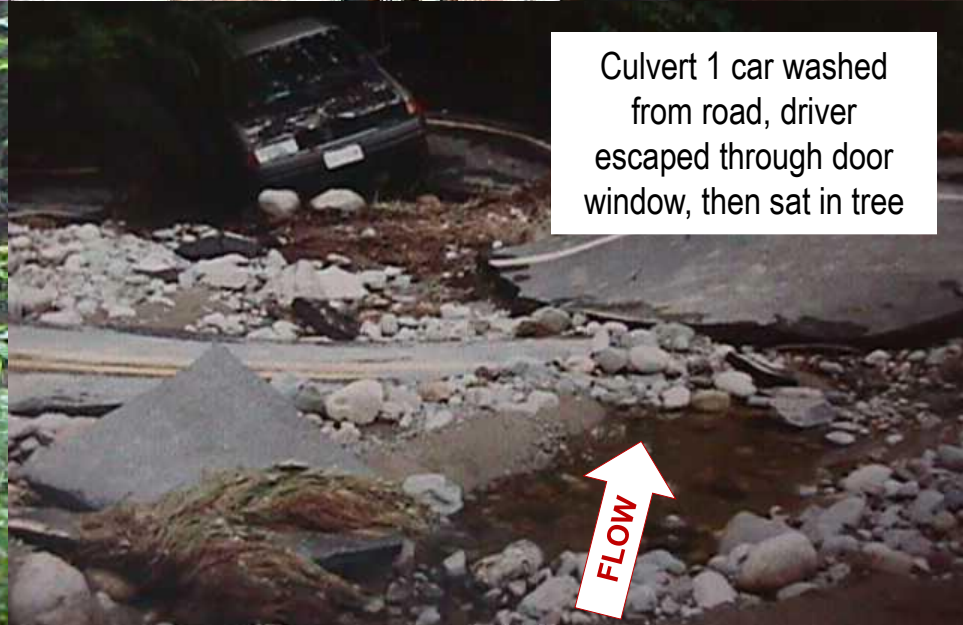
Culvert 1 car washed  
from road, driver  
escaped through door  
window, then sat in tree

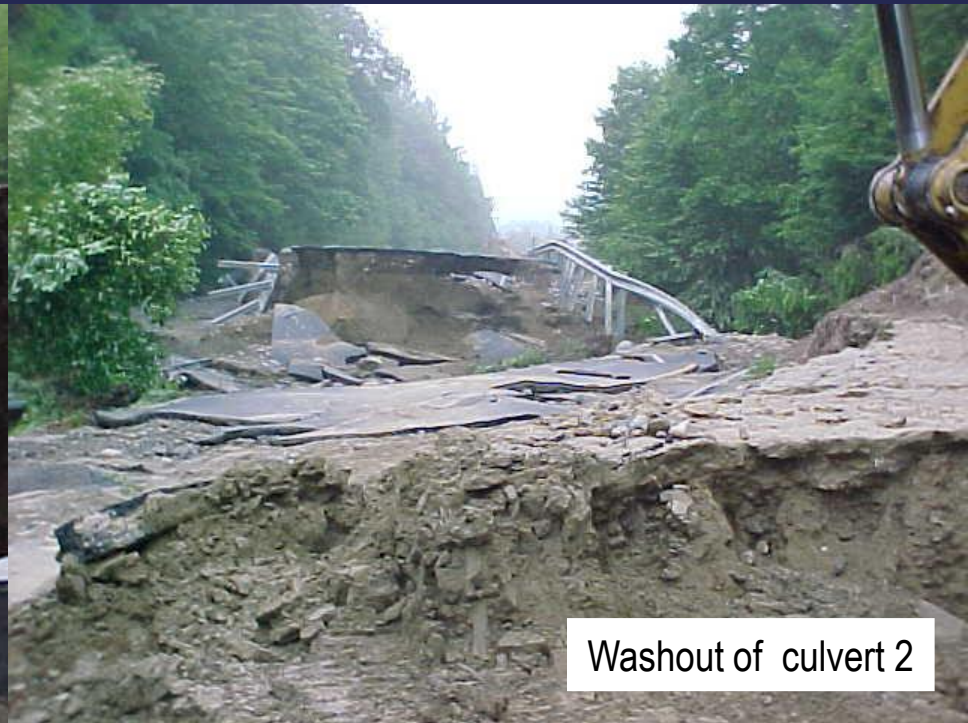
Washout of culvert 2

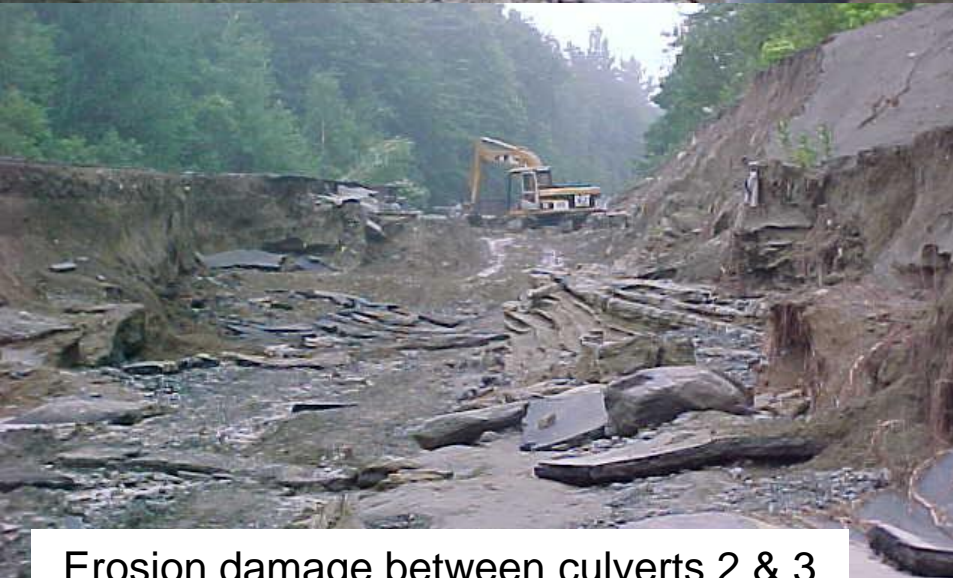
Erosion damage between culverts 2 & 3

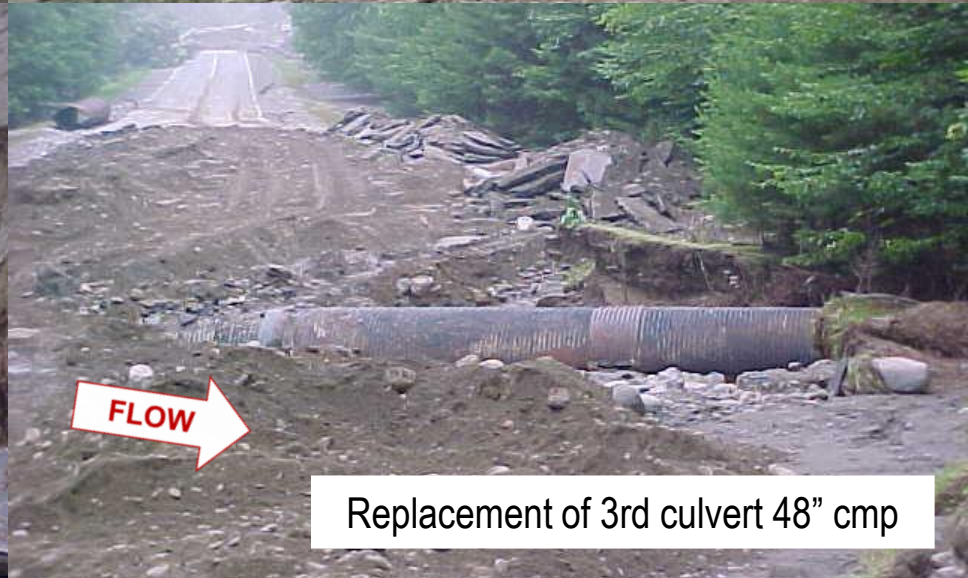
Replacement of 3rd culvert 48" cmp

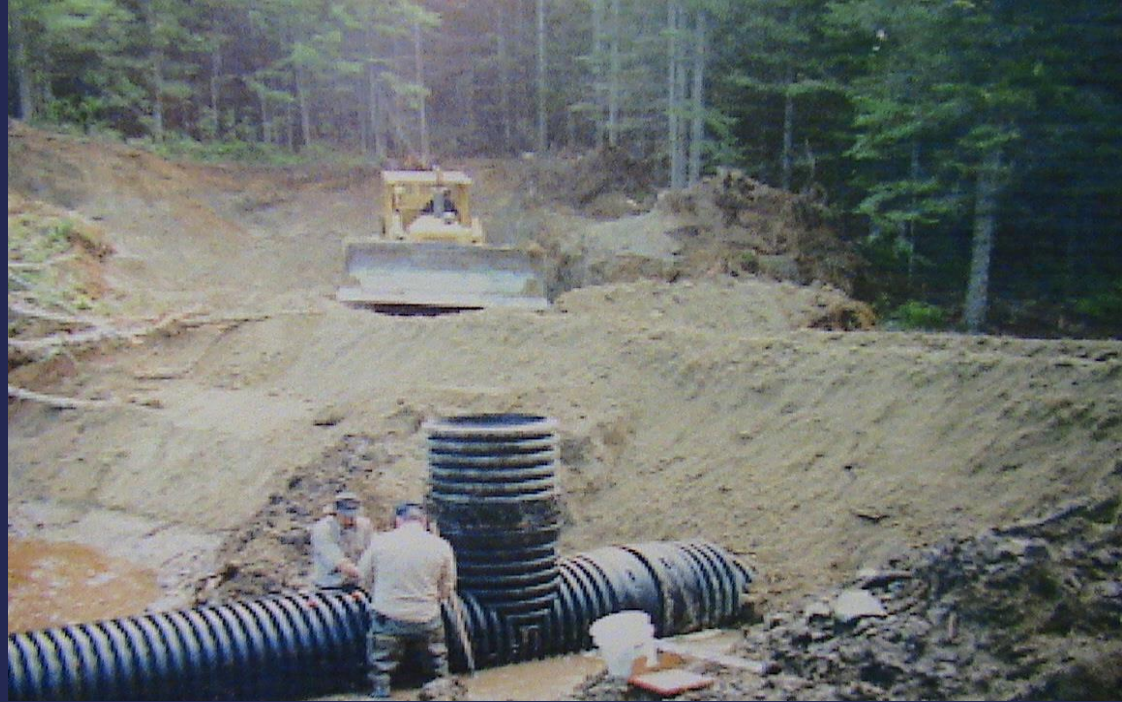
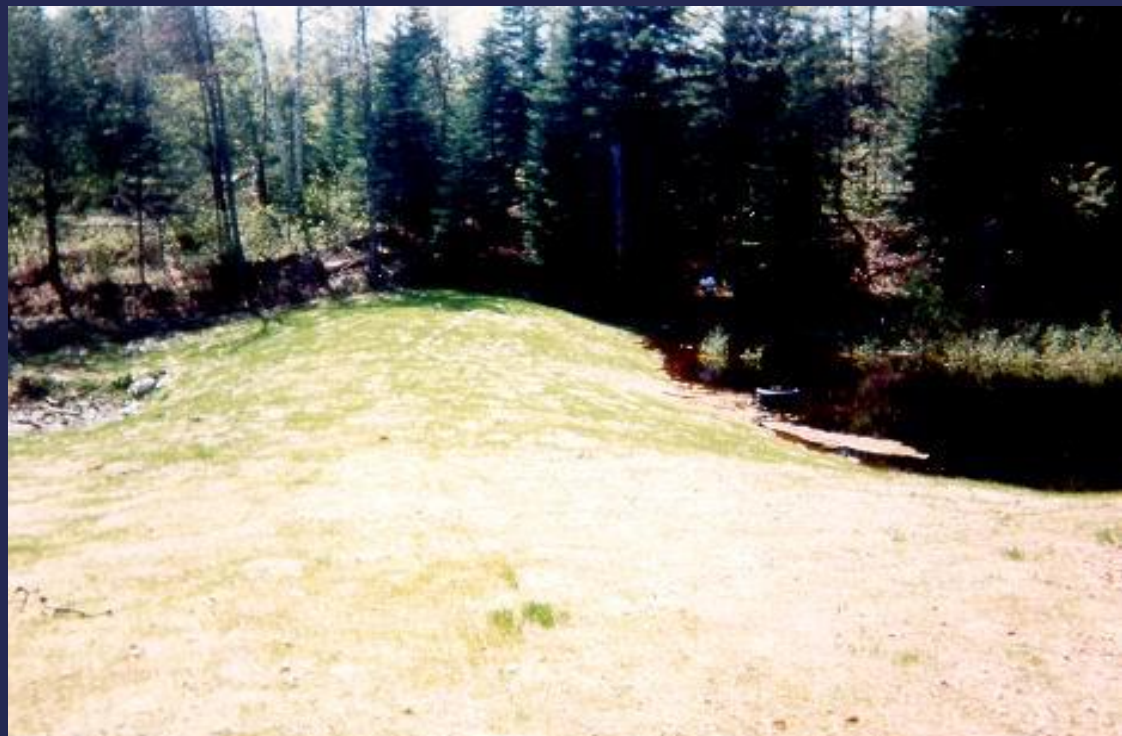
- ❖ No site plan, site investigation, design details, specification or as-built construction records were found. Design plans found were minimal.
- ❖ Principal spillway constructed in black PVC pipe, based on a "Ducks Unlimited" design which assured; a) water control using stop-logs, b) beaver control at both inlets. IFW post breach memo 8/16/200 describes 6-10 cy "native clay" placed around "HiCore C pipe somewhere between the stand pipe and outlet.

- ❖ Emergency spillway, 12' wide x 12" open channel through top of right (north) dike.

- ❑ Type, Time and Date of Failure – Overtopping Breach - 3am - Monday July 17, 2000.
- ❑ Estimated breach flow 4,800 cfs
- ❑ Estimated Damage to road – \$1,000,000 fixed by MDOT, one car but no loss of life.
- ❑ Antecedent conditions - 6 hour, 50 year storm starting Sunday, July 15, 2000 at 1pm.

- ❑ Probable failure mode – blocked primary spillway and riser – inadequate emergency spillway. The breach most likely initiated at the emergency spillway.

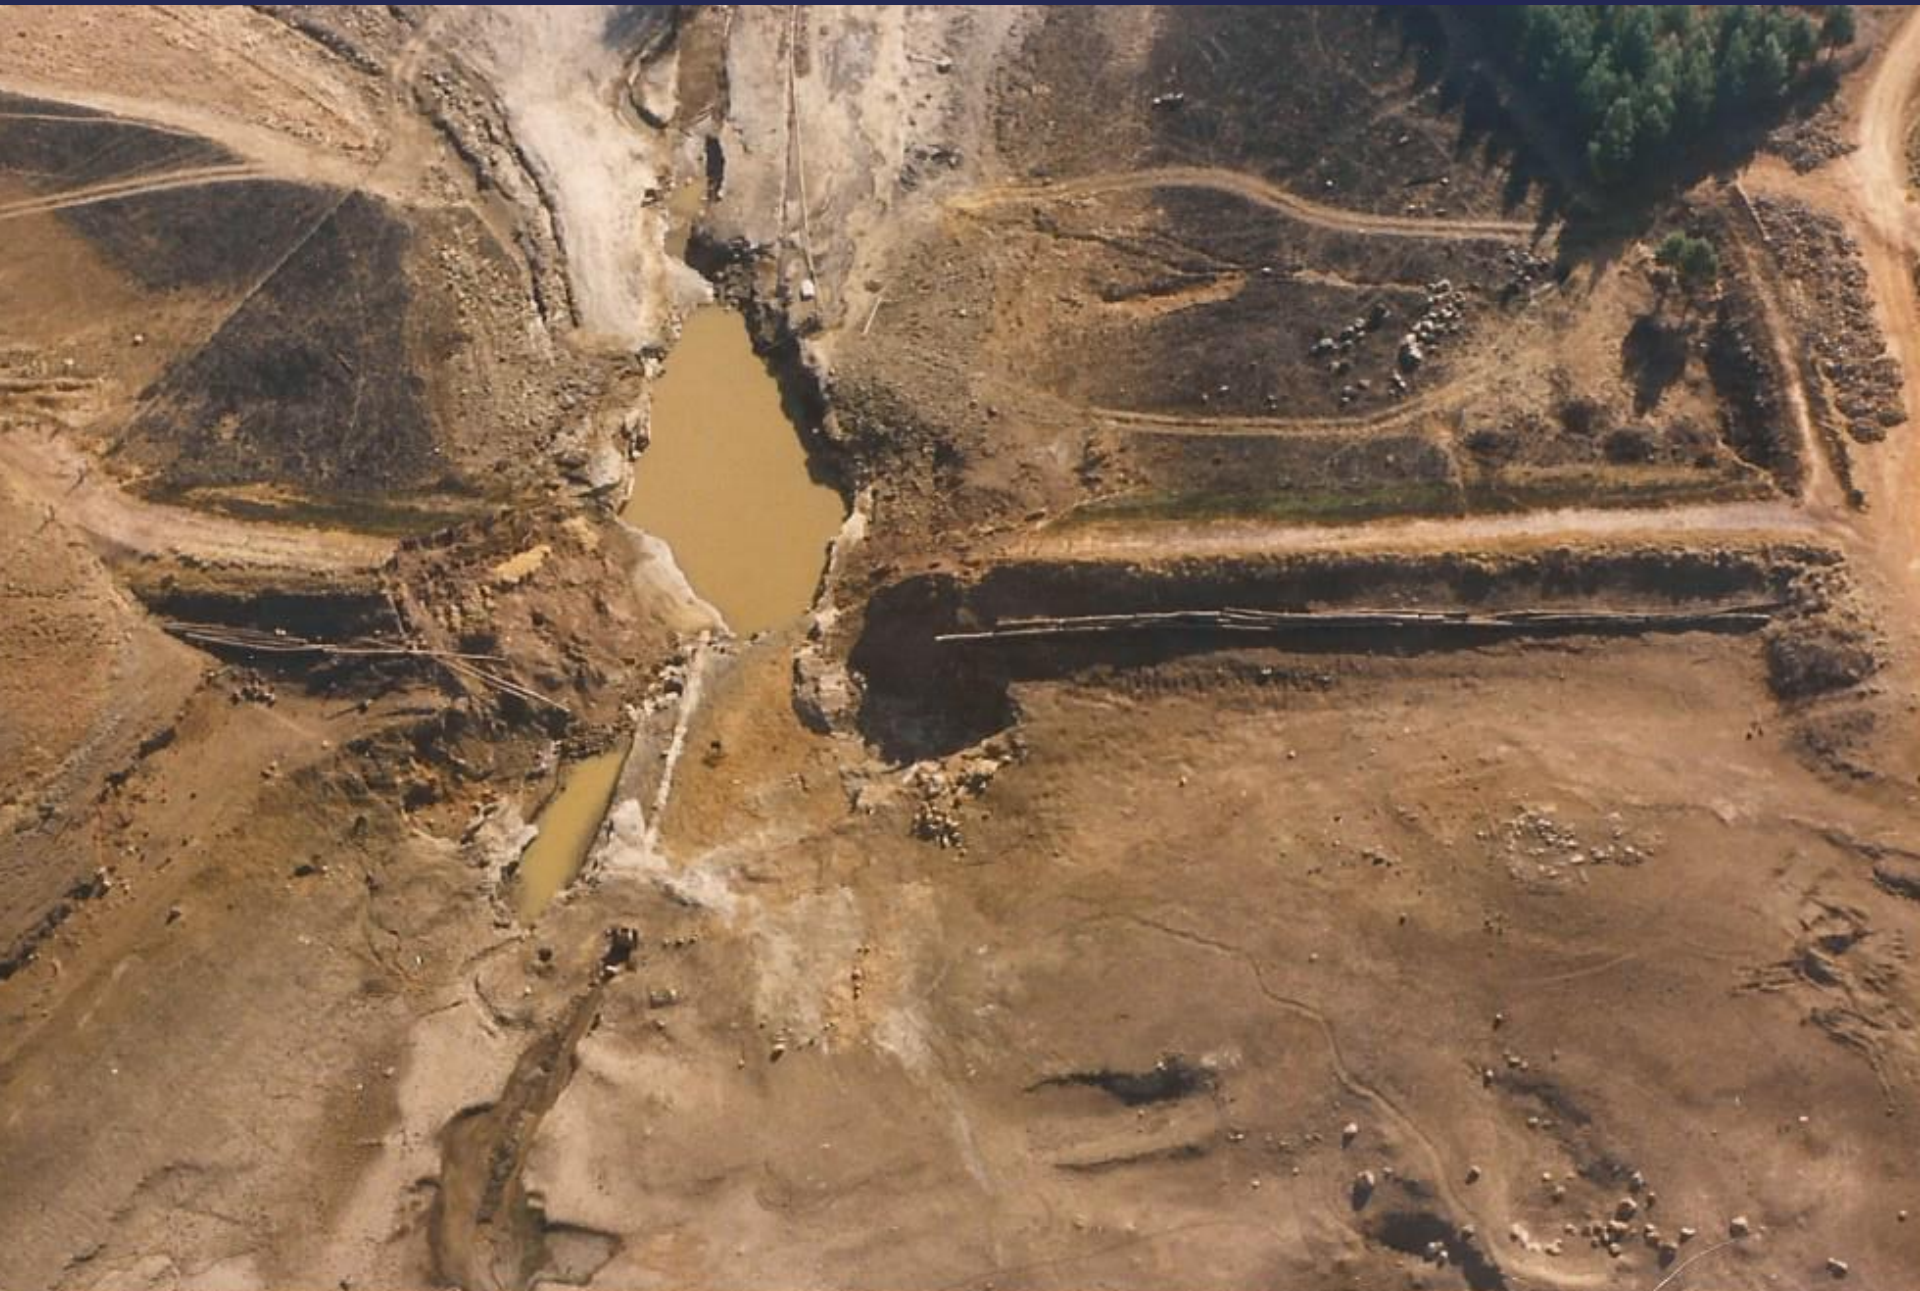
# Failure by Internal Erosion Caused by Seepage & Piping

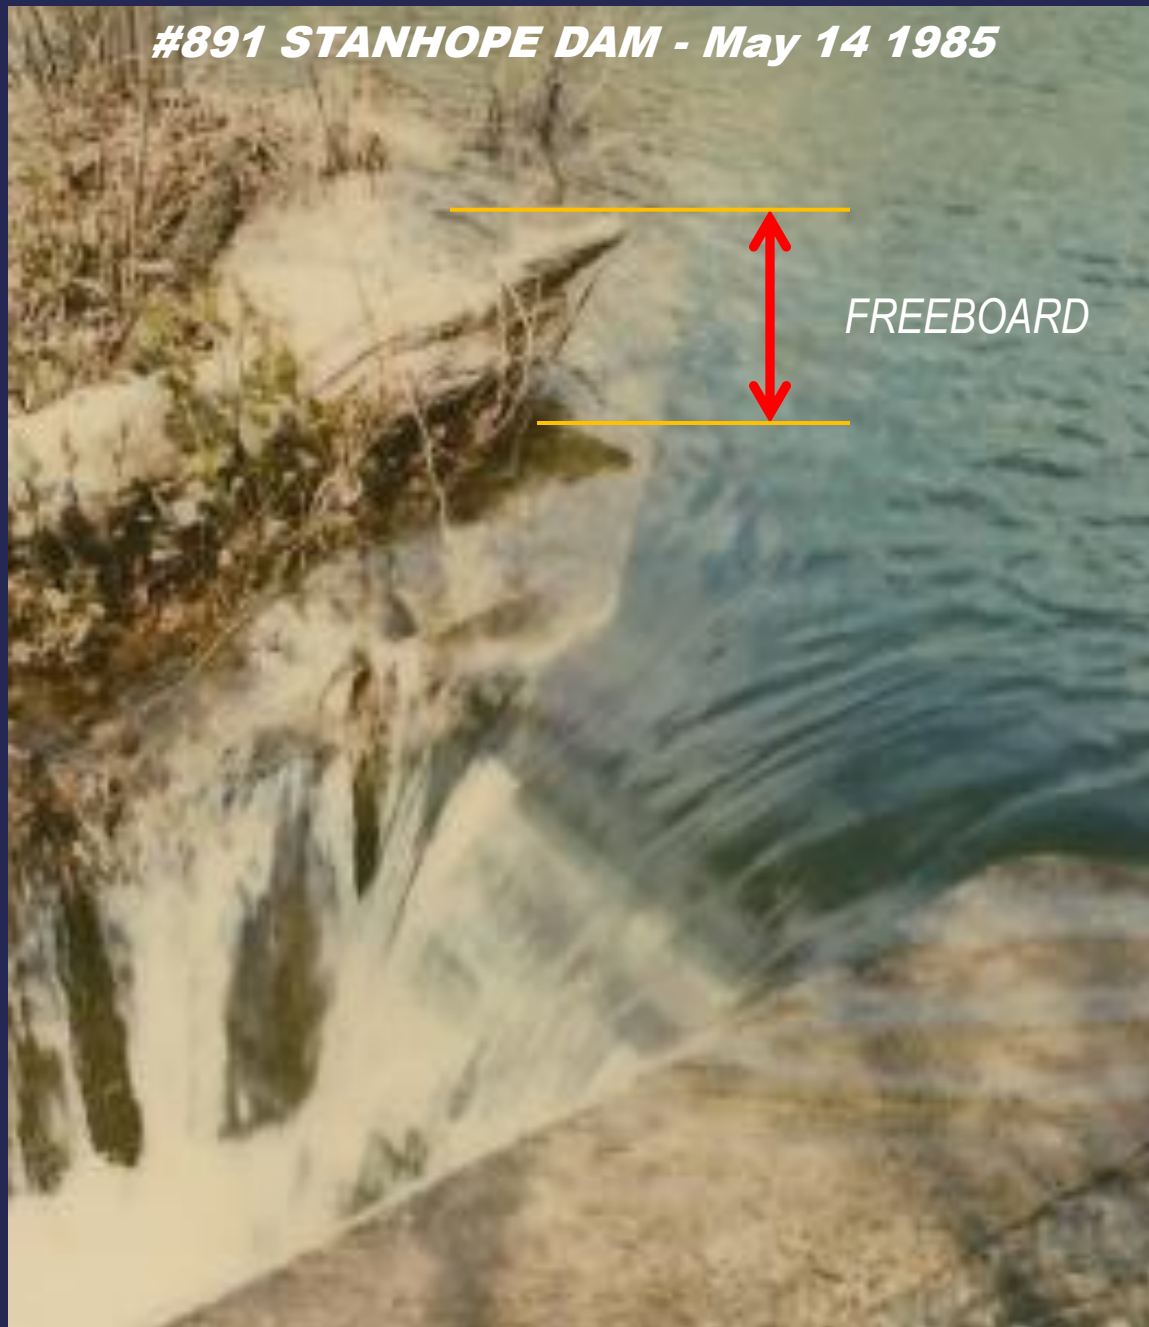
**#891 STANHOPE DAM - May 14 1985**

Dam defect highlighted - Inadequate Spillway

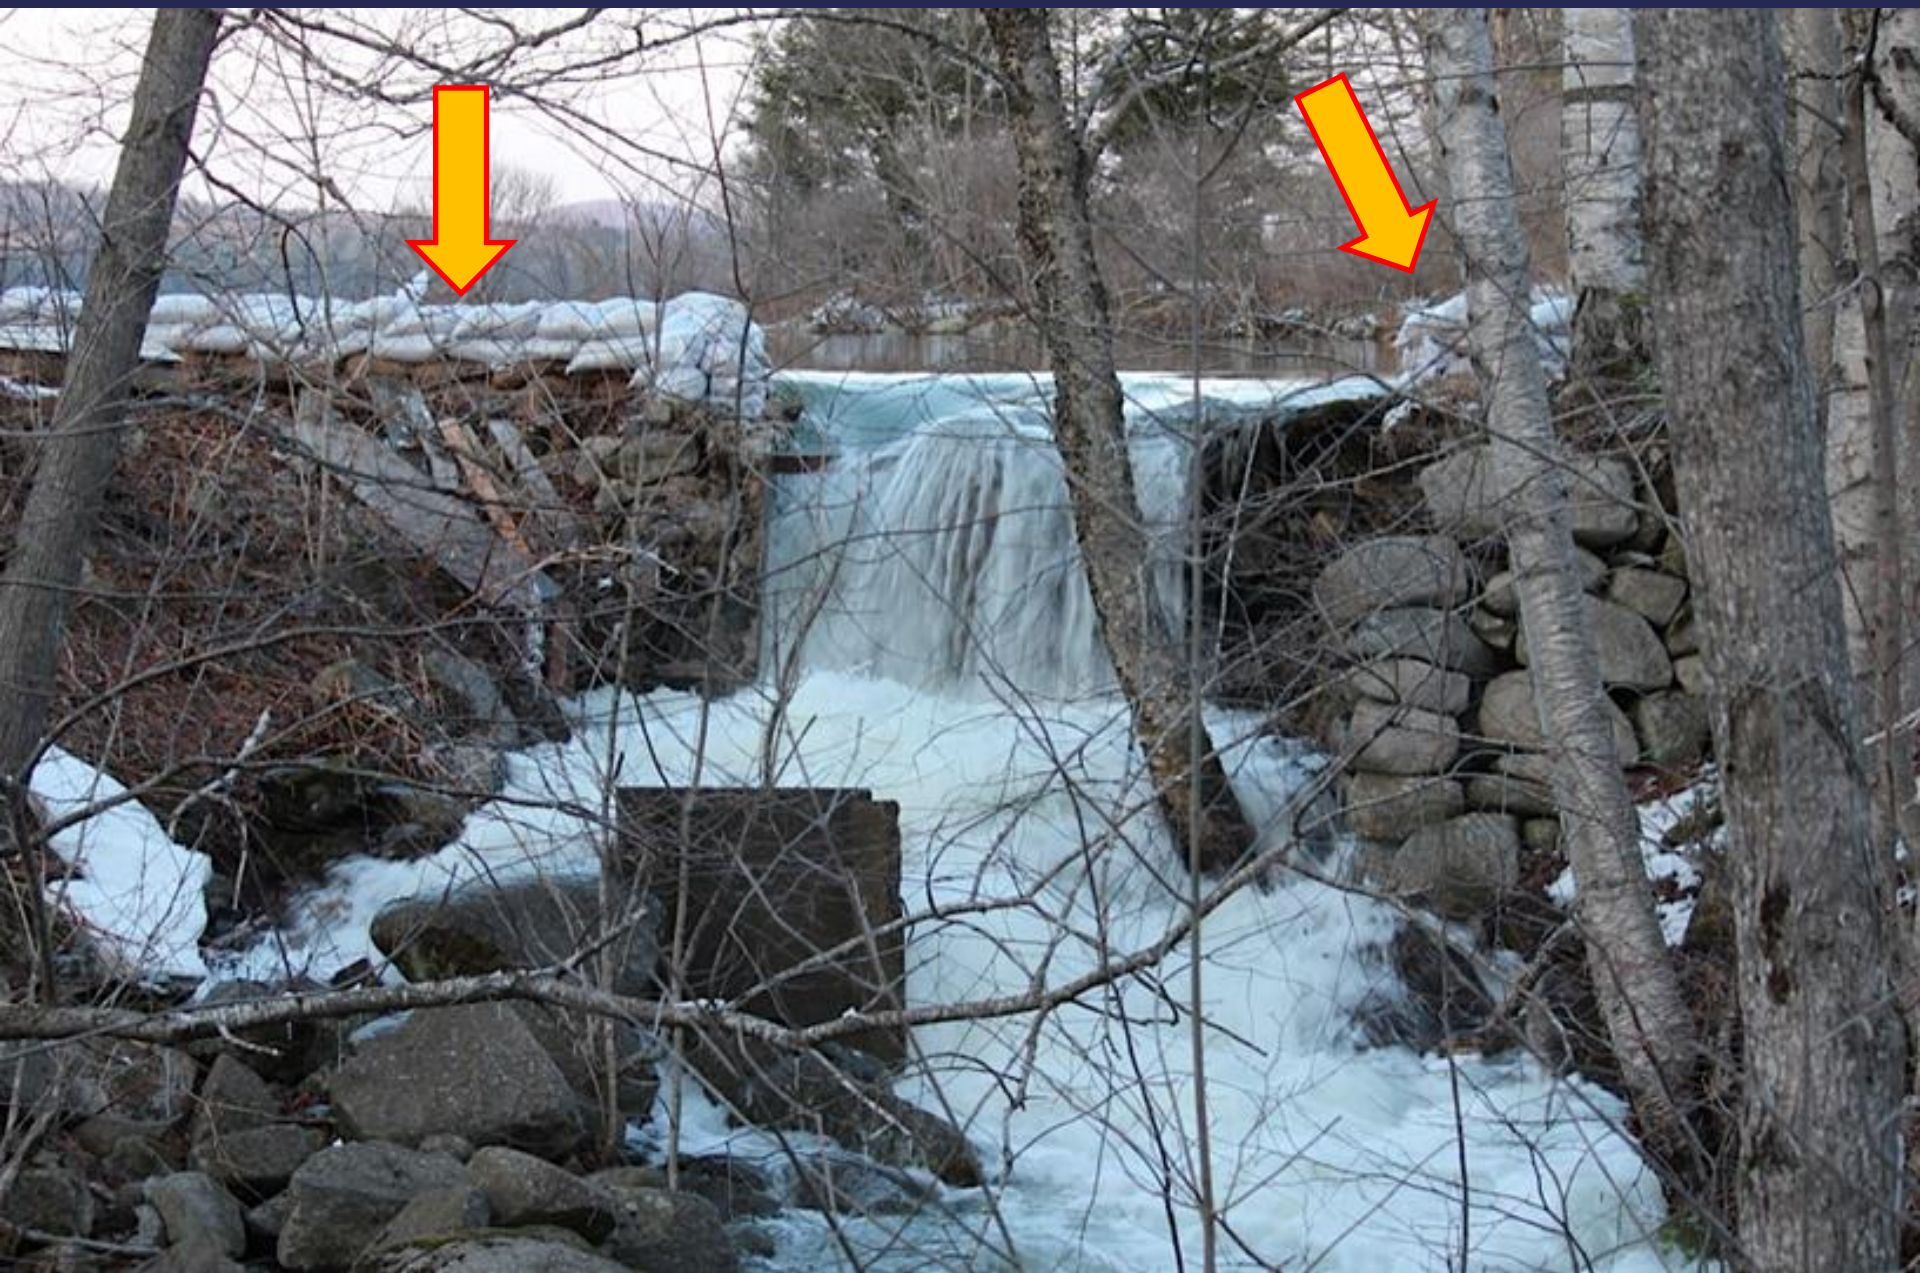
SANDBAGS ON STANHOPE DAM TO INCREASE FREEBOARD & SPILLWAY CAPACITY – April 16, 2014
